ALBUS-KEEFE & ASSOCIATES, INC.
GEOTECHNICAL CONSULTANTS

February 2, 2018
J.N.: 2700.00

Subject: Geotechnical Due-Diligence Investigation and Percolation Study, Proposed Residential Development, 13811 Valley View Avenue, La Mirada, California.

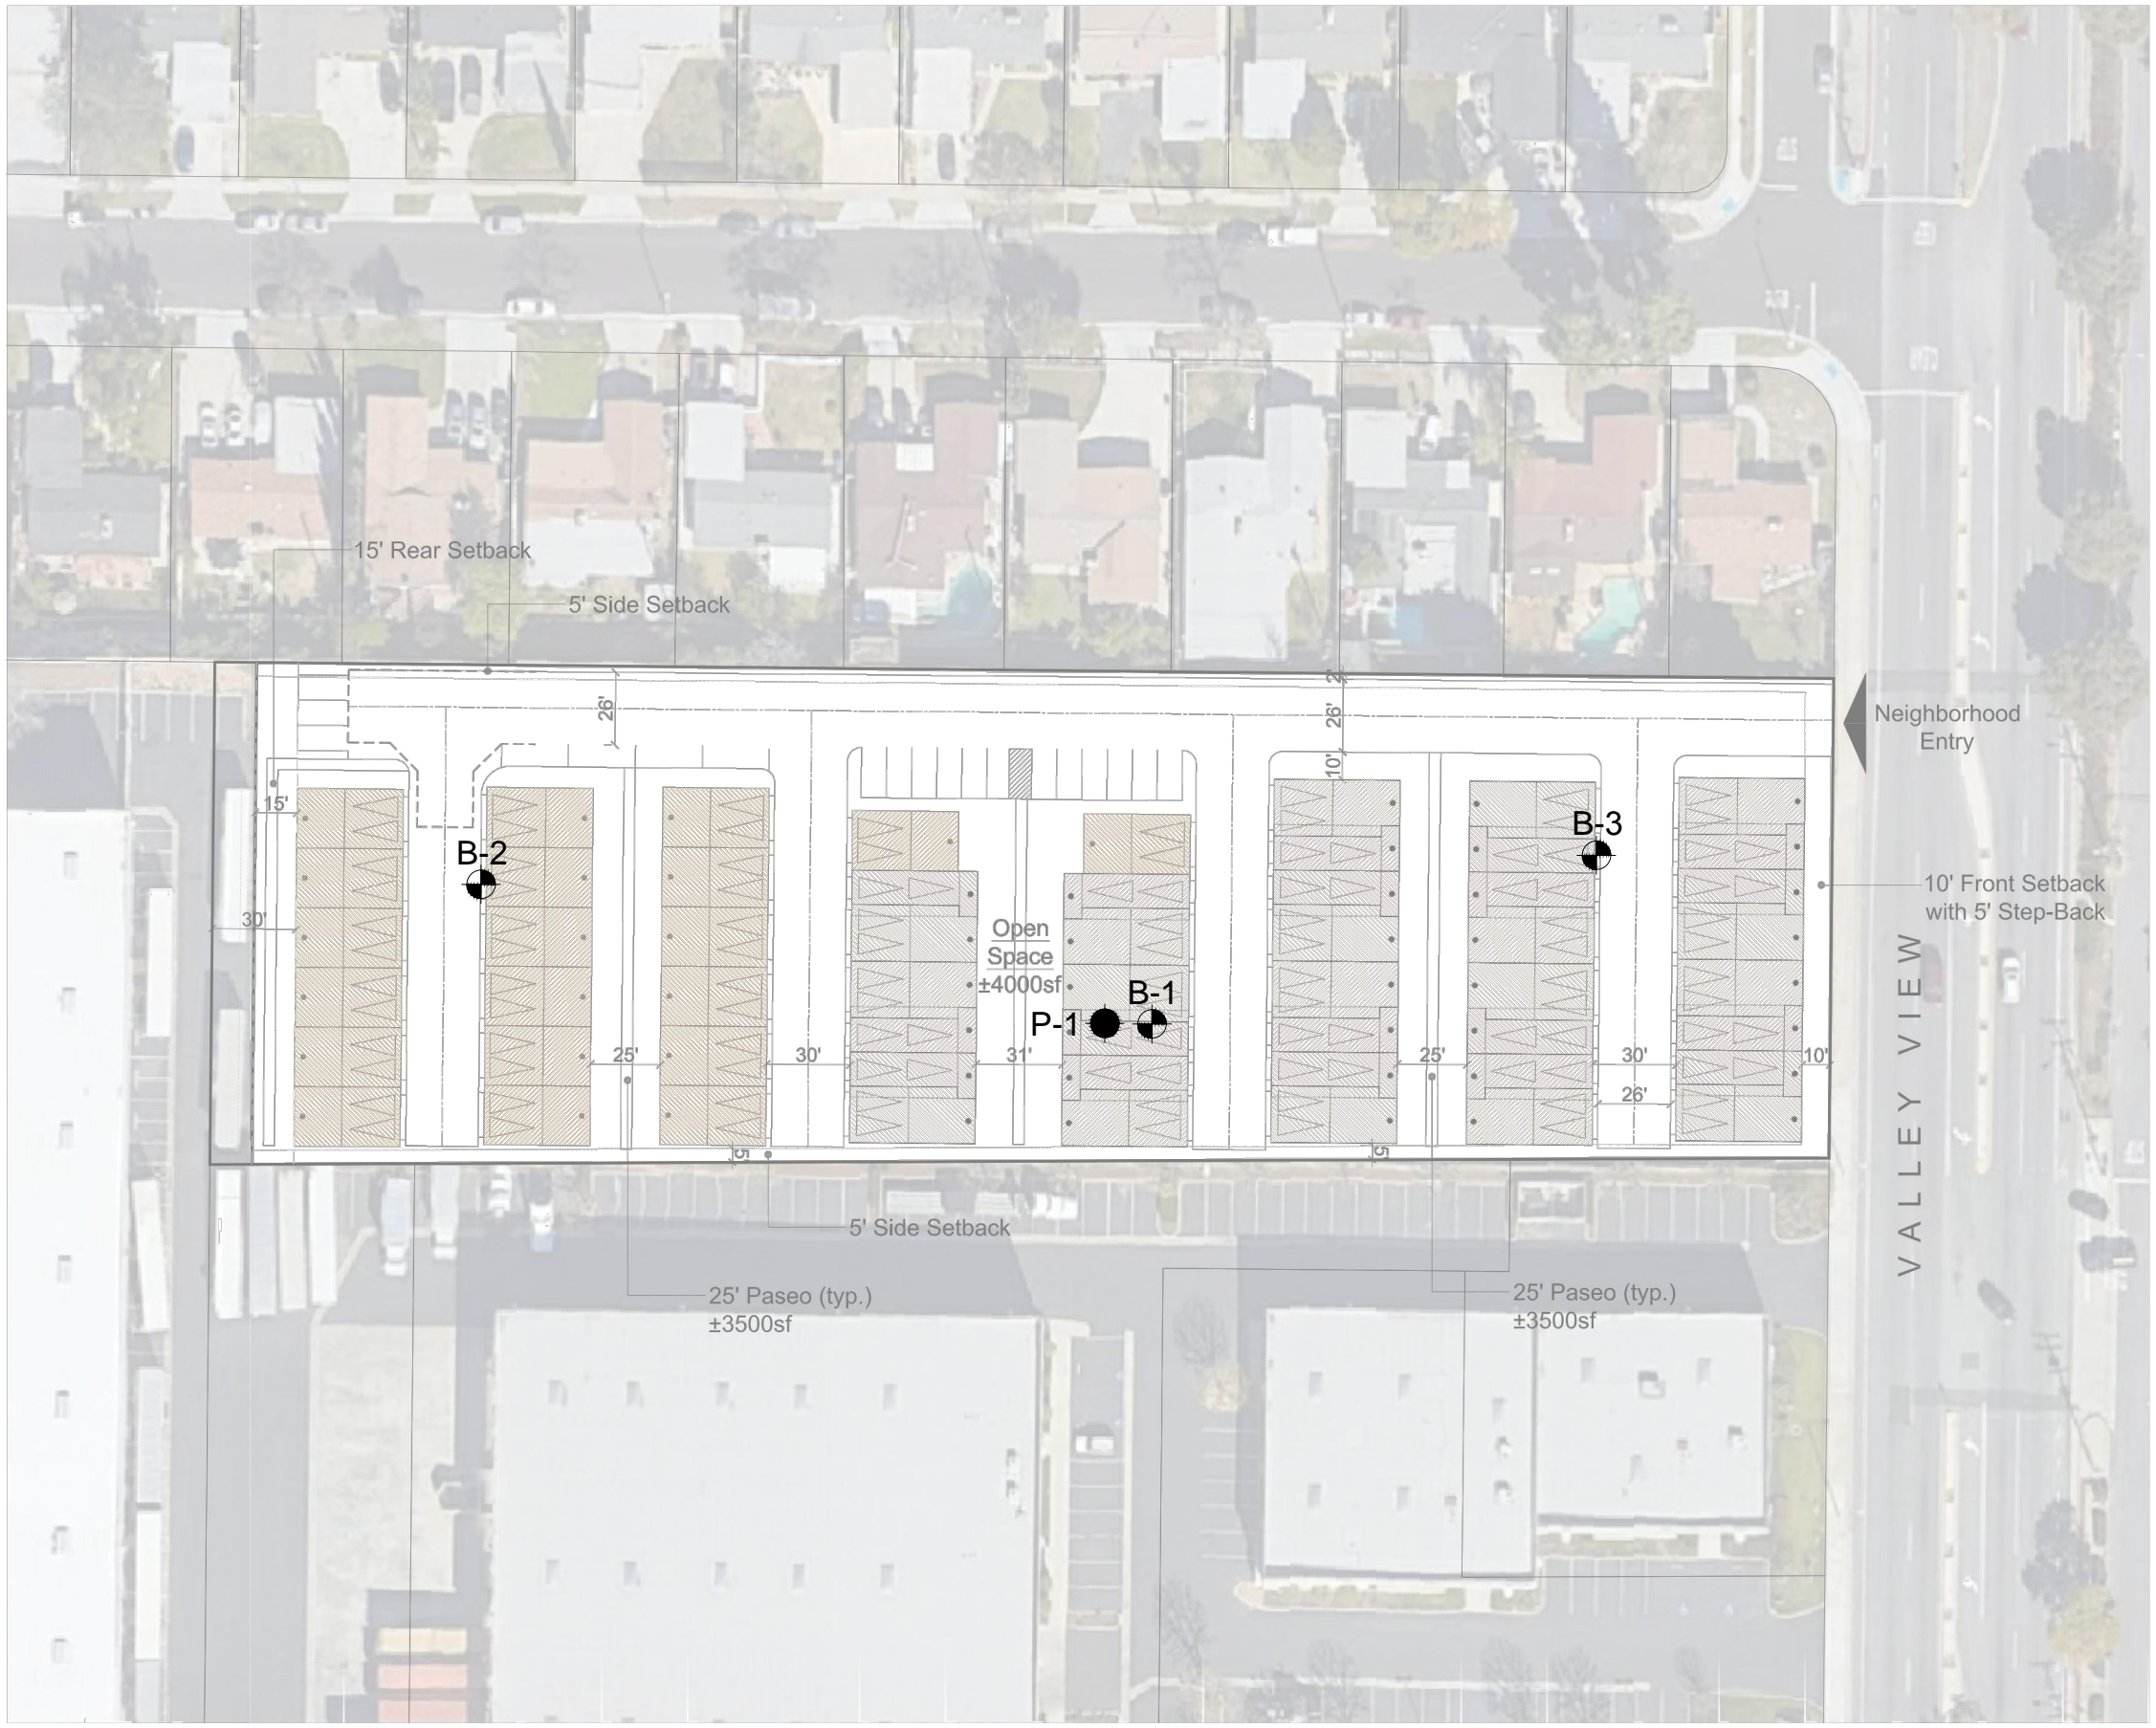
KTGY Architecture + Planning, Conceptual Density Study, Bora & Valley View, La Mirada, LA County, CA, #2017-1142, Dated January 29, 2017

SITE INFORMATION
 Project Name: La Mirada (Bora & Valley View)
 Address: 13811 Valley View Ave, La Mirada, CA 90638
 APN(s): 8059-028-049
 Zoning: M2 Industrial with Special Housing Overlay (Infill Area 8)
 Land Use: Single Family Residential

INFILL AREA 8 DEVELOPMENT STANDARDS
 Front Setback: 10'
 Street Side Setback: 10'
 Side Setback: 5'
 Rear Setback: 10'
 Building Height: 45'
 Coverage 50%
 FAR: 1.0
 Min Floor Step-Back: 5'
 Landscaping: 20%
 Max Density: 30 du/ac

We understand the site will be developed for residential use consisting of 56 units of two- and three-story townhomes. It is anticipated that all proposed structures will be constructed on grade (i.e. no subterranean elements). The main street is planned along the north portion of the site. Associated interior driveways, perimeter/retaining walls, storm water infiltration system, and underground utilities are also planned.

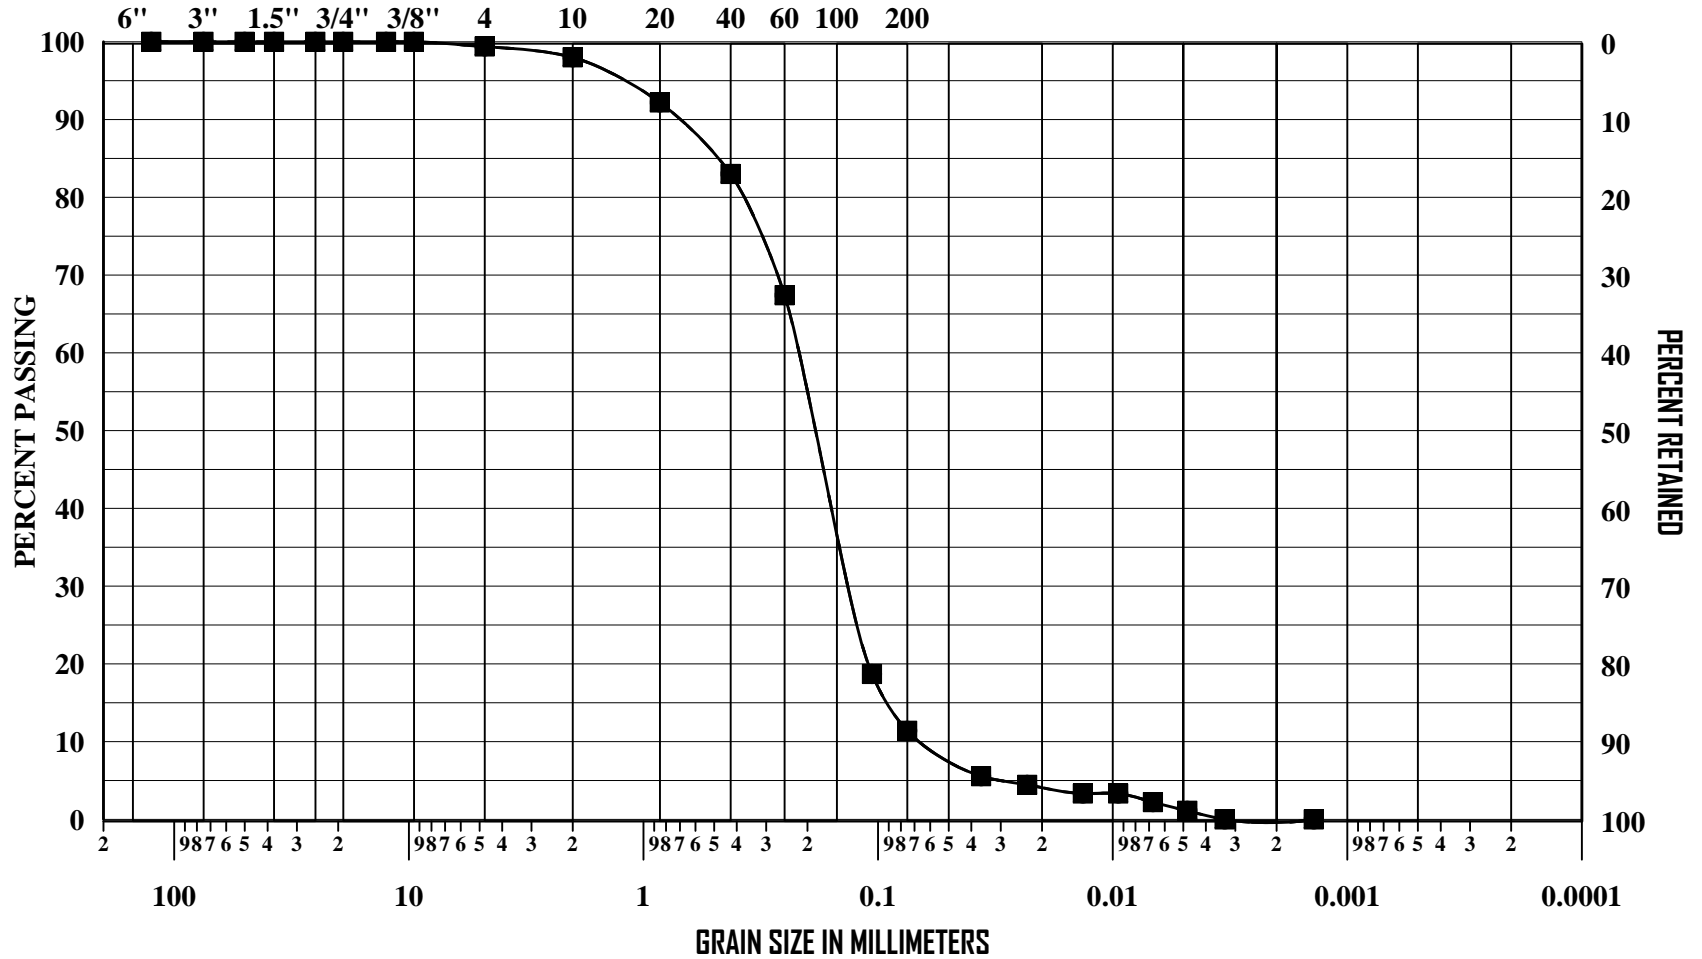
Job No: 2700.00
Plate No: B-1

COBBLES	GRAVEL		SAND			SILT AND CLAY
	COARSE	FINE	COARSE	MEDIUM	FINE

U.S. STANDARD SIEVE SIZES

LOCATION	SAMPLE	SYMBOL	LL	PI	CLASSIFICATION
P-1	28 feet	●————●			Sand with Silt (SP-SM)

GRAIN SIZE DISTRIBUTION

Selected samples of representative earth materials from the borings were tested in our laboratory. Tests consisted of in-situ moisture and dry density, maximum dry density and optimum moisture content, expansion index, soluble sulfate content, consolidation/collapse potential, direct shear, corrosivity (pH, chloride, & minimum resistivity), Atterberg limits, and grain size analysis. Descriptions of laboratory testing and a summary of the test results are presented in Appendix B and on the exploration log in Appendix A.

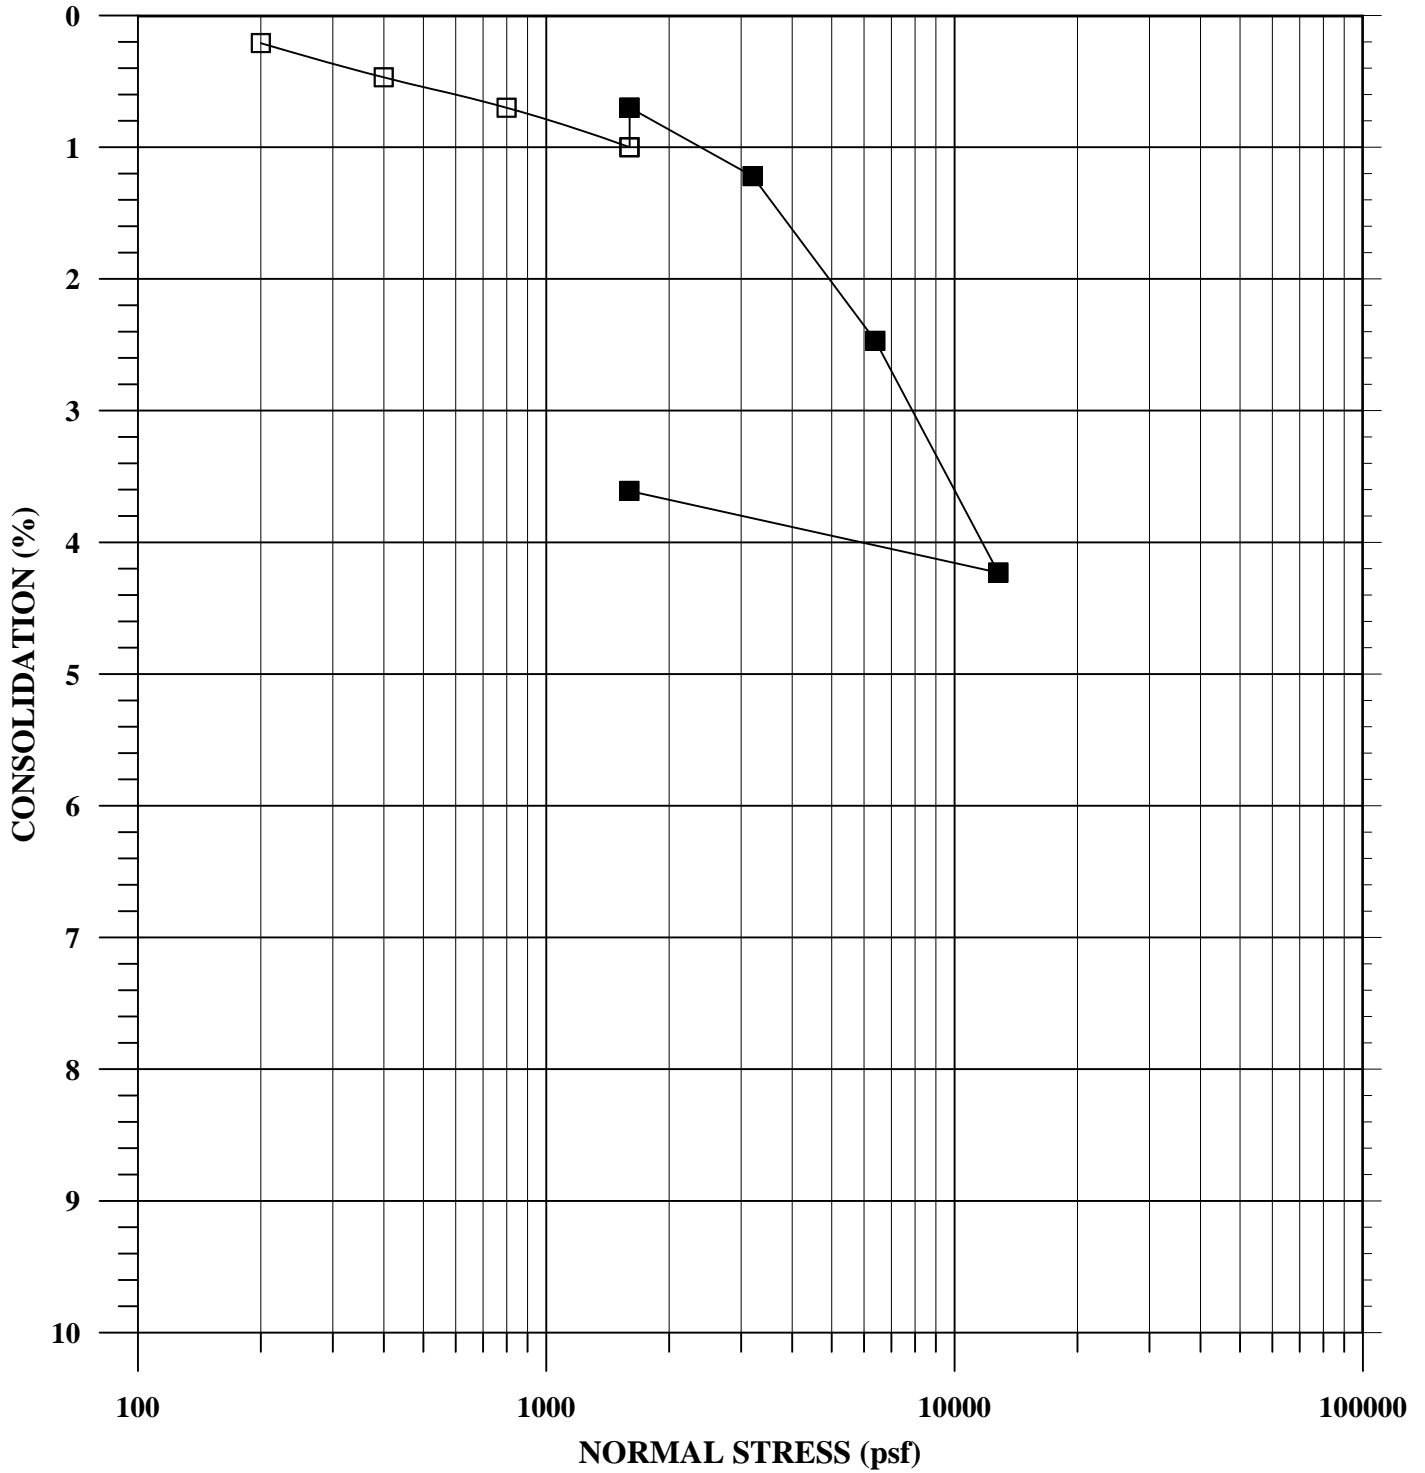
ALBUS-KEEFE & ASSOCIATES, INC. GEOTECHNICAL CONSULTANTS	CONSOLIDATION TEST RESULTS	Job No: 2700.00
		Plate No: B-2

Sample Location:	B-1	Initial Dry Density (pcf):	114.7	Legend	
Sample Depth:	4 ft	Initial Moisture Content (%):	9.4		□ □ □ Field Moisture
Classification:	CL	Final Moisture Content (%):	14.6		■ — ■ — ■ Saturated

Our exploration and laboratory testing indicated the alluvial soils are porous and prone to significant hydrocollapse. These materials are likely to cause settlements beyond the tolerances of proposed site development in their current state. If the upper 4 to 6 feet of older alluvial soils are removed and replaced as compacted fill, total and differential static settlements are anticipated to be less than 1 inch and ½-inch over 30 feet, respectively. The greater depths of removals are anticipated to be along the east portion of the site. These estimated magnitudes of static settlements are considered within tolerable limits for the proposed foundation loads.

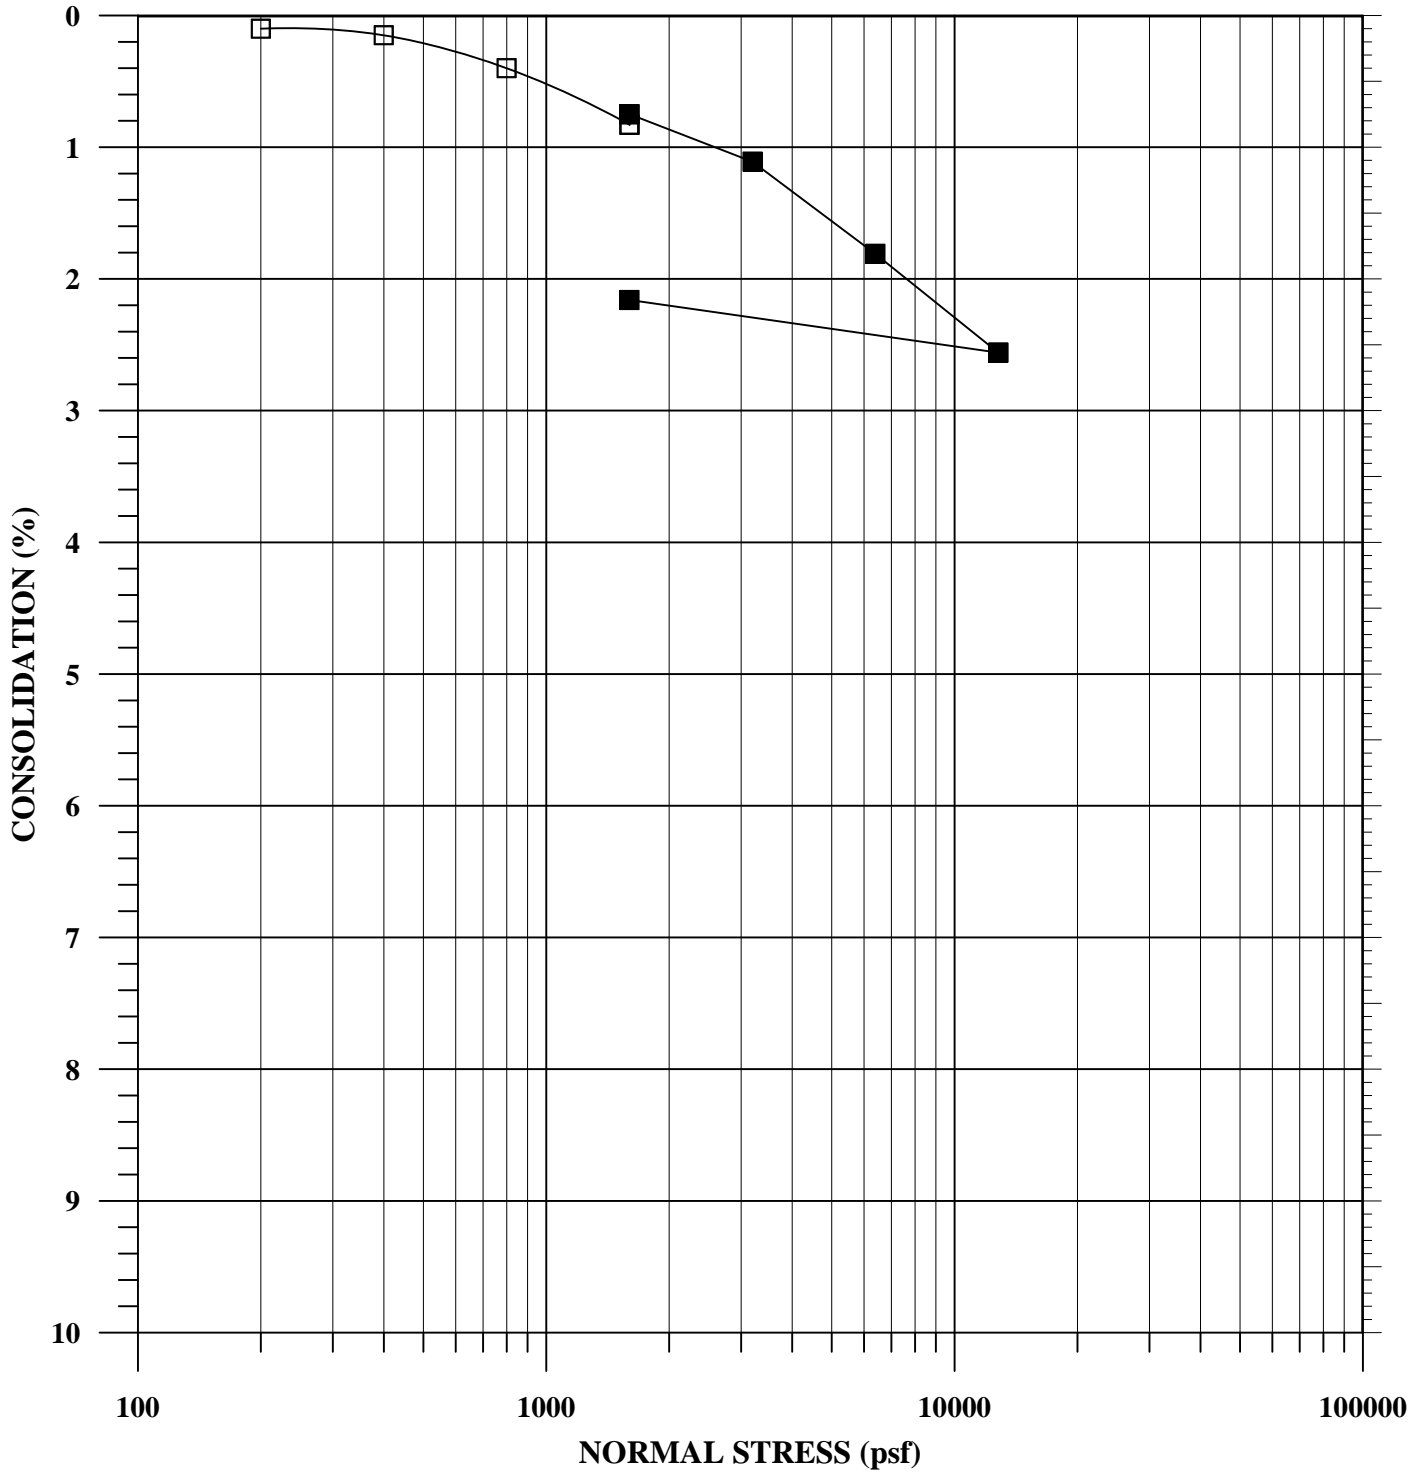
ALBUS-KEEFE & ASSOCIATES, INC. GEOTECHNICAL CONSULTANTS	CONSOLIDATION TEST RESULTS	Job No: 2700.00
		Plate No: B-3

Sample Location:	B-1	Initial Dry Density (pcf):	109.0	Legend □ □ □ Field Moisture ■ — ■ — ■ Saturated
Sample Depth:	6 ft	Initial Moisture Content (%):	8.3	
Classification:	SC/SM	Final Moisture Content (%):	16.2

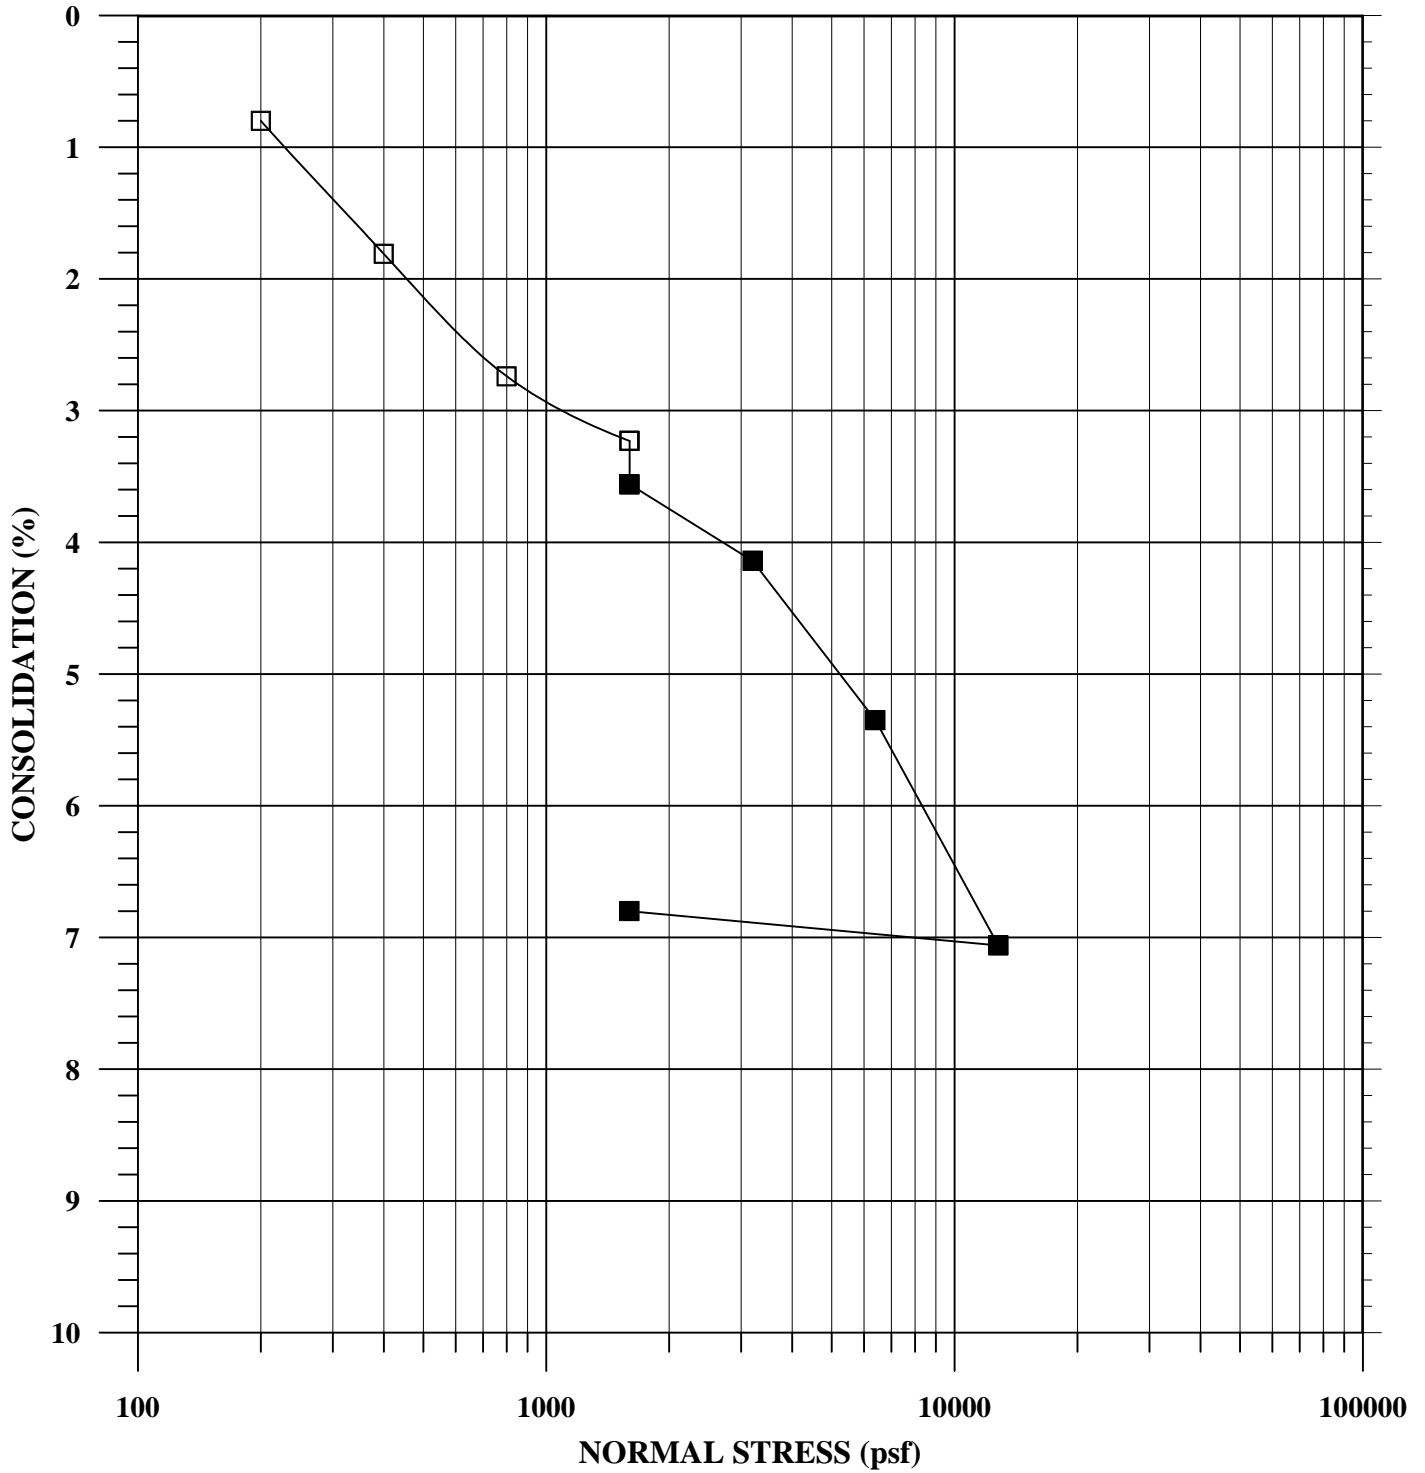
ALBUS-KEEFE & ASSOCIATES, INC. GEOTECHNICAL CONSULTANTS	CONSOLIDATION TEST RESULTS	Job No: 2700.00
		Plate No: B-4

Sample Location:	B-2	Initial Dry Density (pcf):	-68.1	Legend □ □ □ Field Moisture ■ — ■ — ■ Saturated
Sample Depth:	6 ft	Initial Moisture Content (%):	-328.3	
Classification:	ML/SM	Final Moisture Content (%):	-341

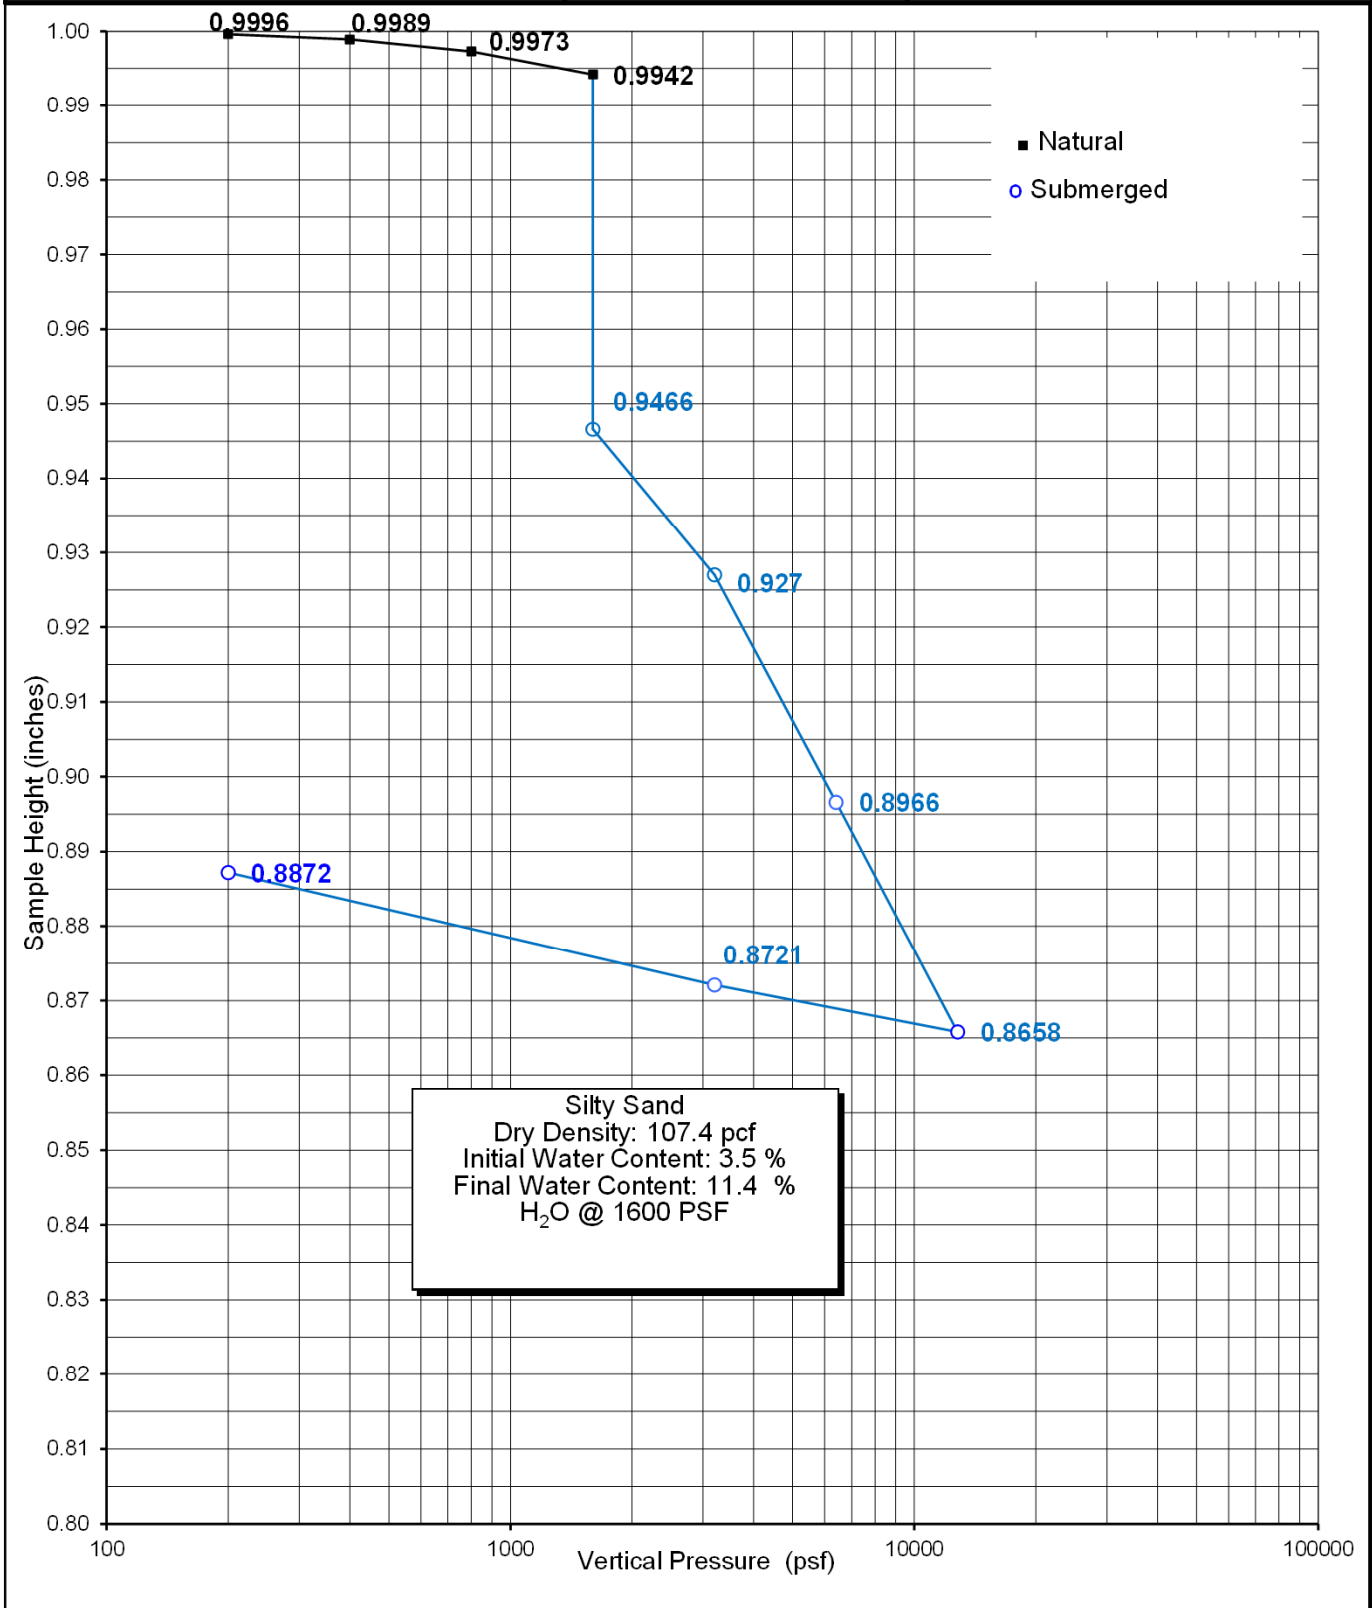
Boring / Sample No.	B-3	Depth:	4'	Date	01-23-18
---------------------	-----	--------	----	------	----------

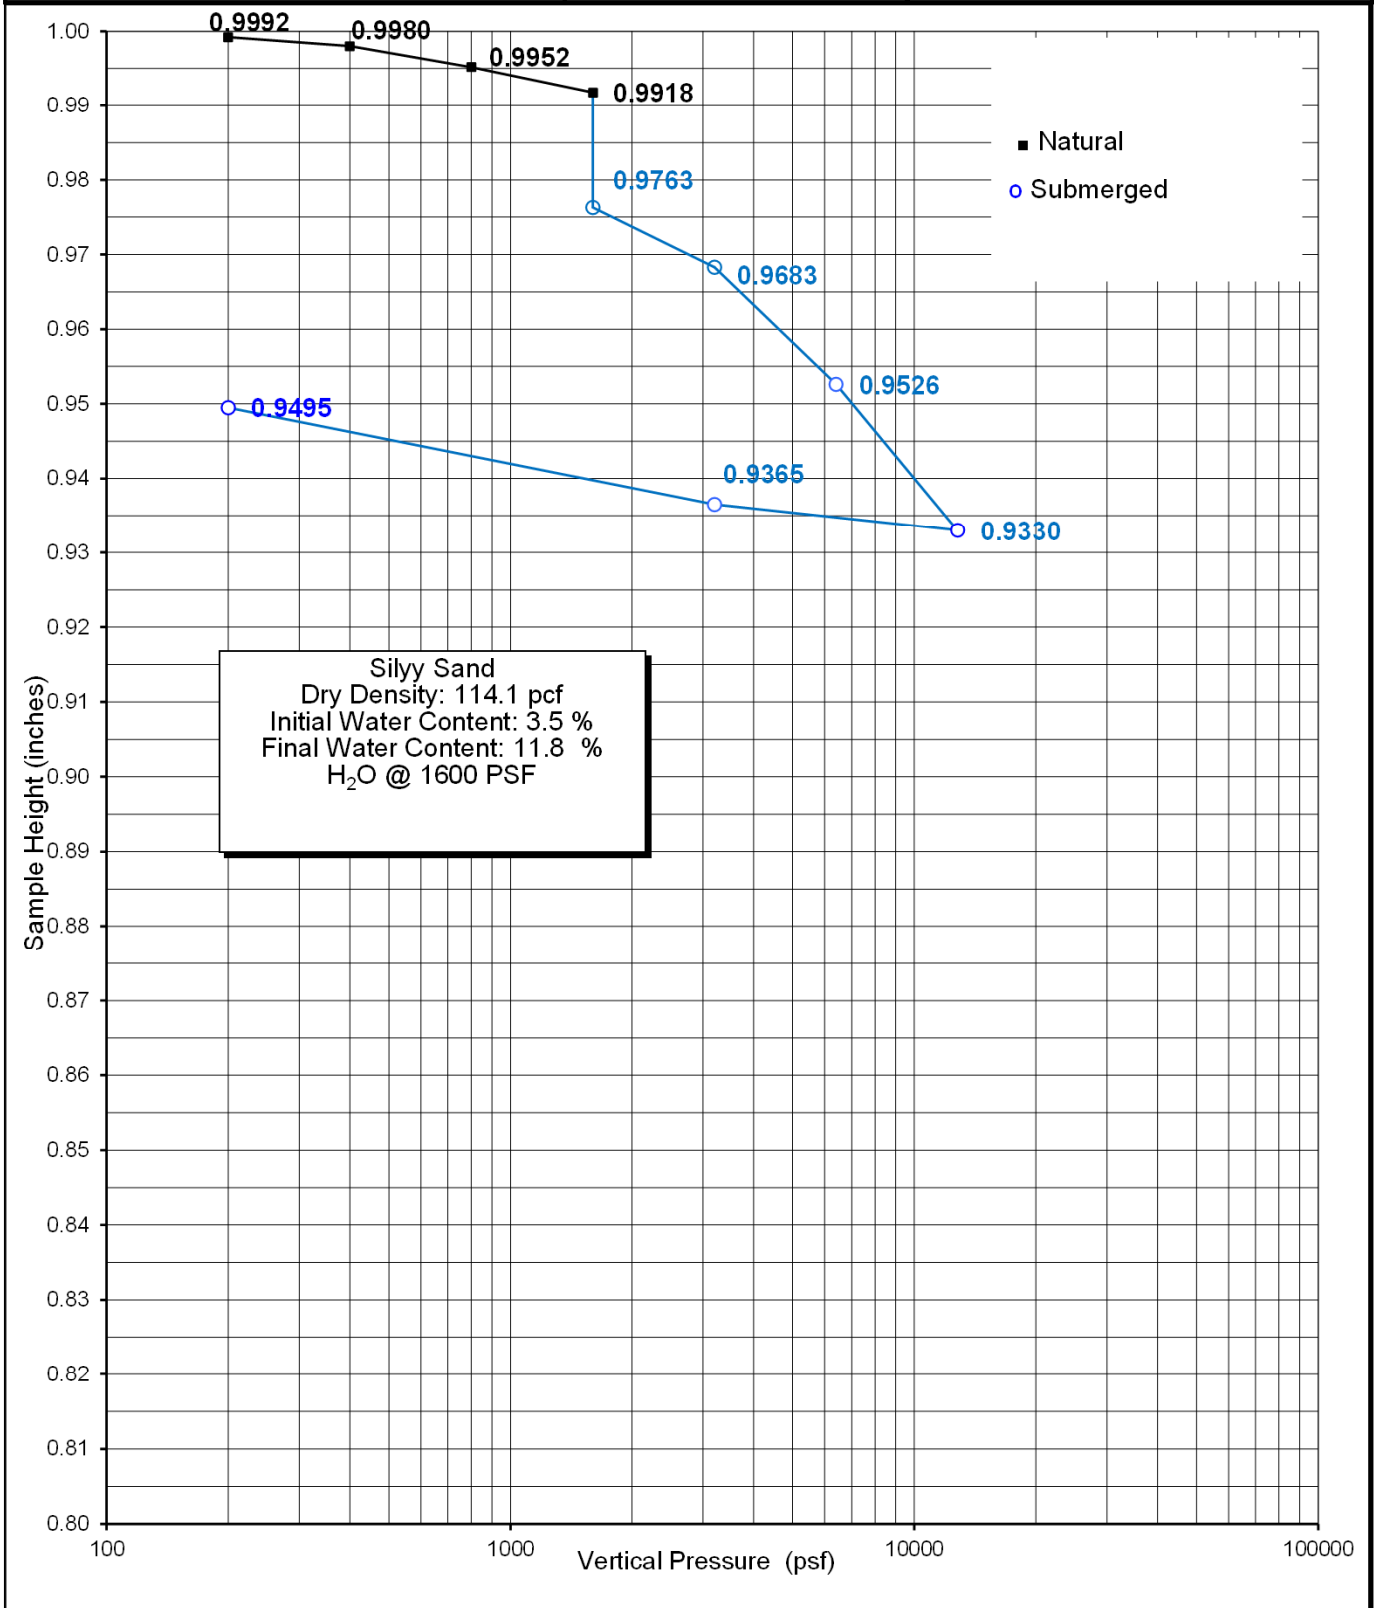
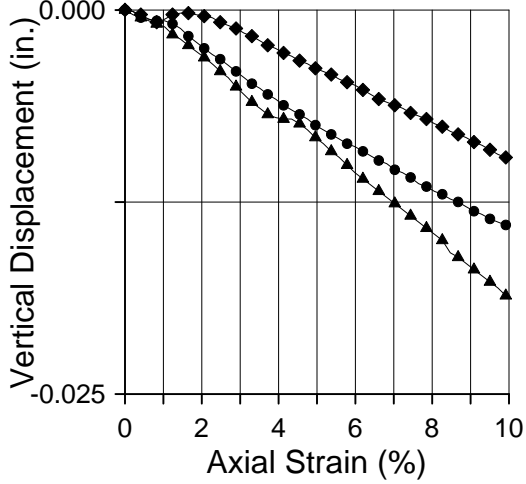
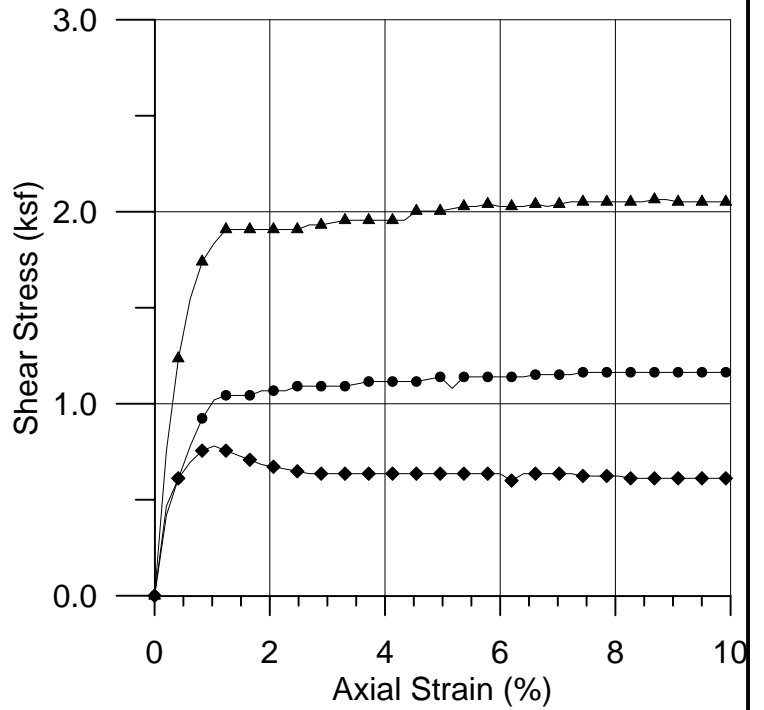
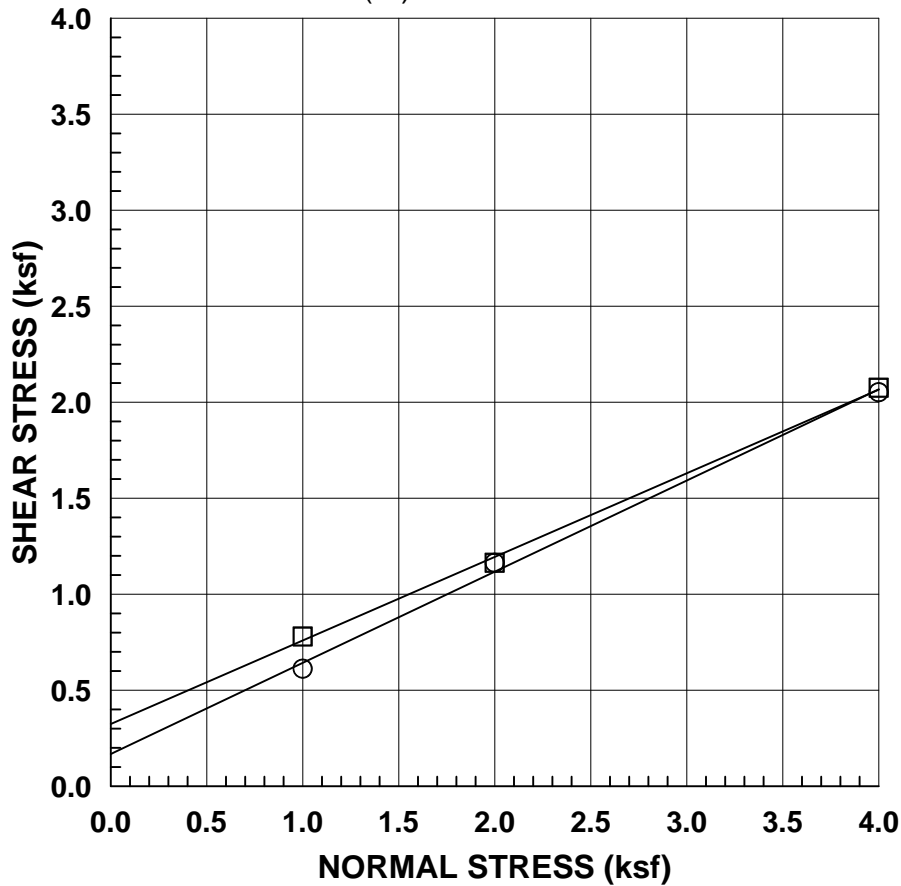
Boring / Sample No.	B-3	Depth:	10'	Date	01-23-18
---------------------	-----	--------	-----	------	----------

Specimen No.	1	2	3
Normal Stress (ksf)	1	2	4
Peak Shear Stress (ksf)	0.78	1.164	2.076
Peak Displacement (in)	0.01	0.015	0.02
Ultimate Shear Stress (ksf)	0.612	1.164	2.052
Ultimate Displacement (in)	0.25	0.25	0.25
Initial Dry Density (pcf)	115.7	115.7	115.7
Initial Moisture Content (%)	10.5	10.5	10.5
Strain Rate (in/min)	0.005

Strain Legend	
◆	1
●	2
▲	4

Strength Legend	
□	Peak
○	Ultimate
