# HYDROLOGY STUDY

TR No 82127  
VALLEY VIEW  
13811 VALLEY VEIW AVE  
LA MIRADA, CA  
COUNTY OF LOS ANGELES

PREPARED BY:  
B & E Engineers  
20 E. Foothill Blvd, Ste 230  
Arcadia Ca. 91006  
TEL. (626) 446-4449  
FAX. (626) 446-6566

**MAY** 2019  
JN. 2017420  
BY: *George G*

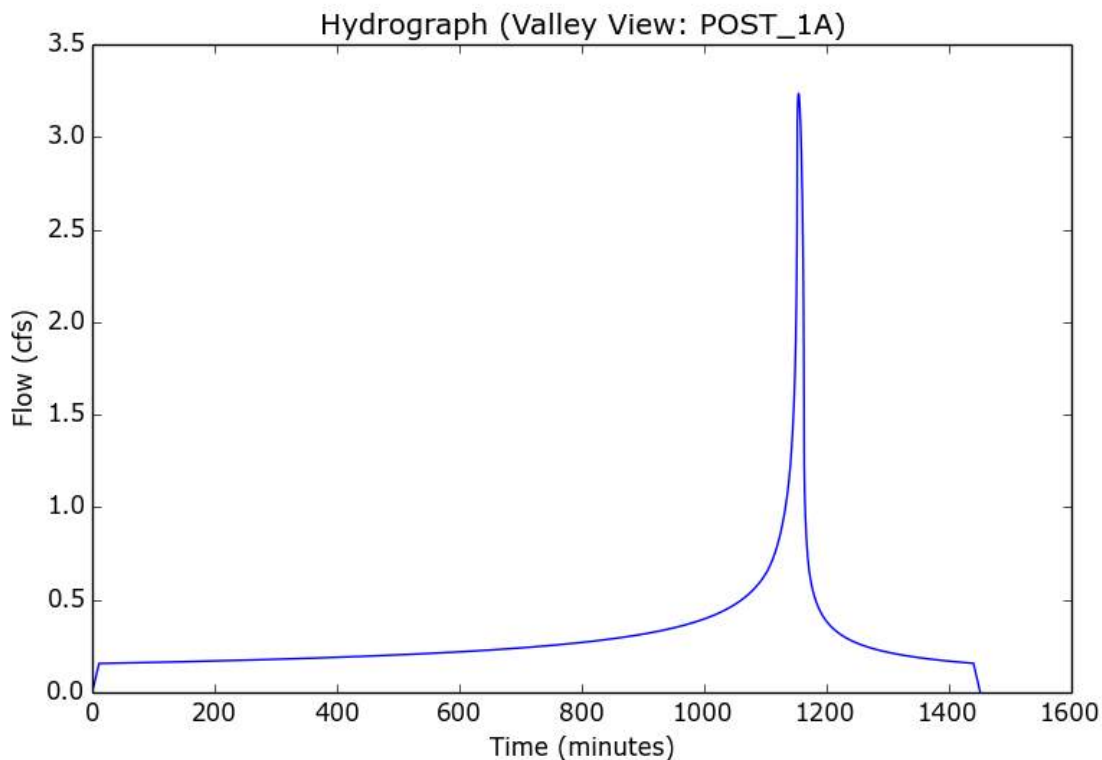
Modeled (10-yr) Rainfall Depth (in)	3.9984
Peak Intensity (in/hr)	1.6468
Undeveloped Runoff Coefficient (Cu)	0.6935
Developed Runoff Coefficient (Cd)	0.869
Time of Concentration (min)	11.0
Clear Peak Flow Rate (cfs)	3.2344
Burned Peak Flow Rate (cfs)	3.2344
24-Hr Clear Runoff Volume (ac-ft)	0.5905
24-Hr Clear Runoff Volume (cu-ft)	25723.3

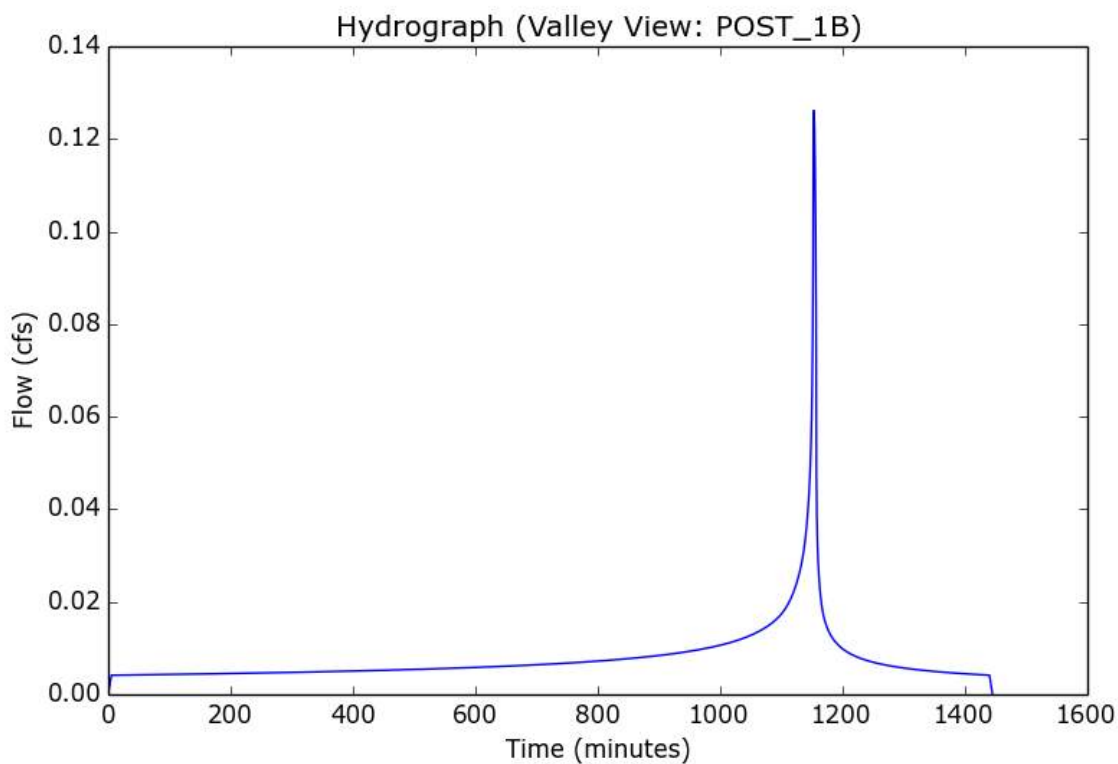
Modeled (10-yr) Rainfall Depth (in)	3.9984
Peak Intensity (in/hr)	2.3856
Undeveloped Runoff Coefficient (Cu)	0.7746
Developed Runoff Coefficient (Cd)	0.8812
Time of Concentration (min)	5.0
Clear Peak Flow Rate (cfs)	0.1261
Burned Peak Flow Rate (cfs)	0.1261
24-Hr Clear Runoff Volume (ac-ft)	0.0157
24-Hr Clear Runoff Volume (cu-ft)	683.0633
